# Walk Around

## Focke-Wulf Fw 190A/F

Walk Around Number 22  
squadron/signal publications

By Malcolm Laing and E. Brown Ryle

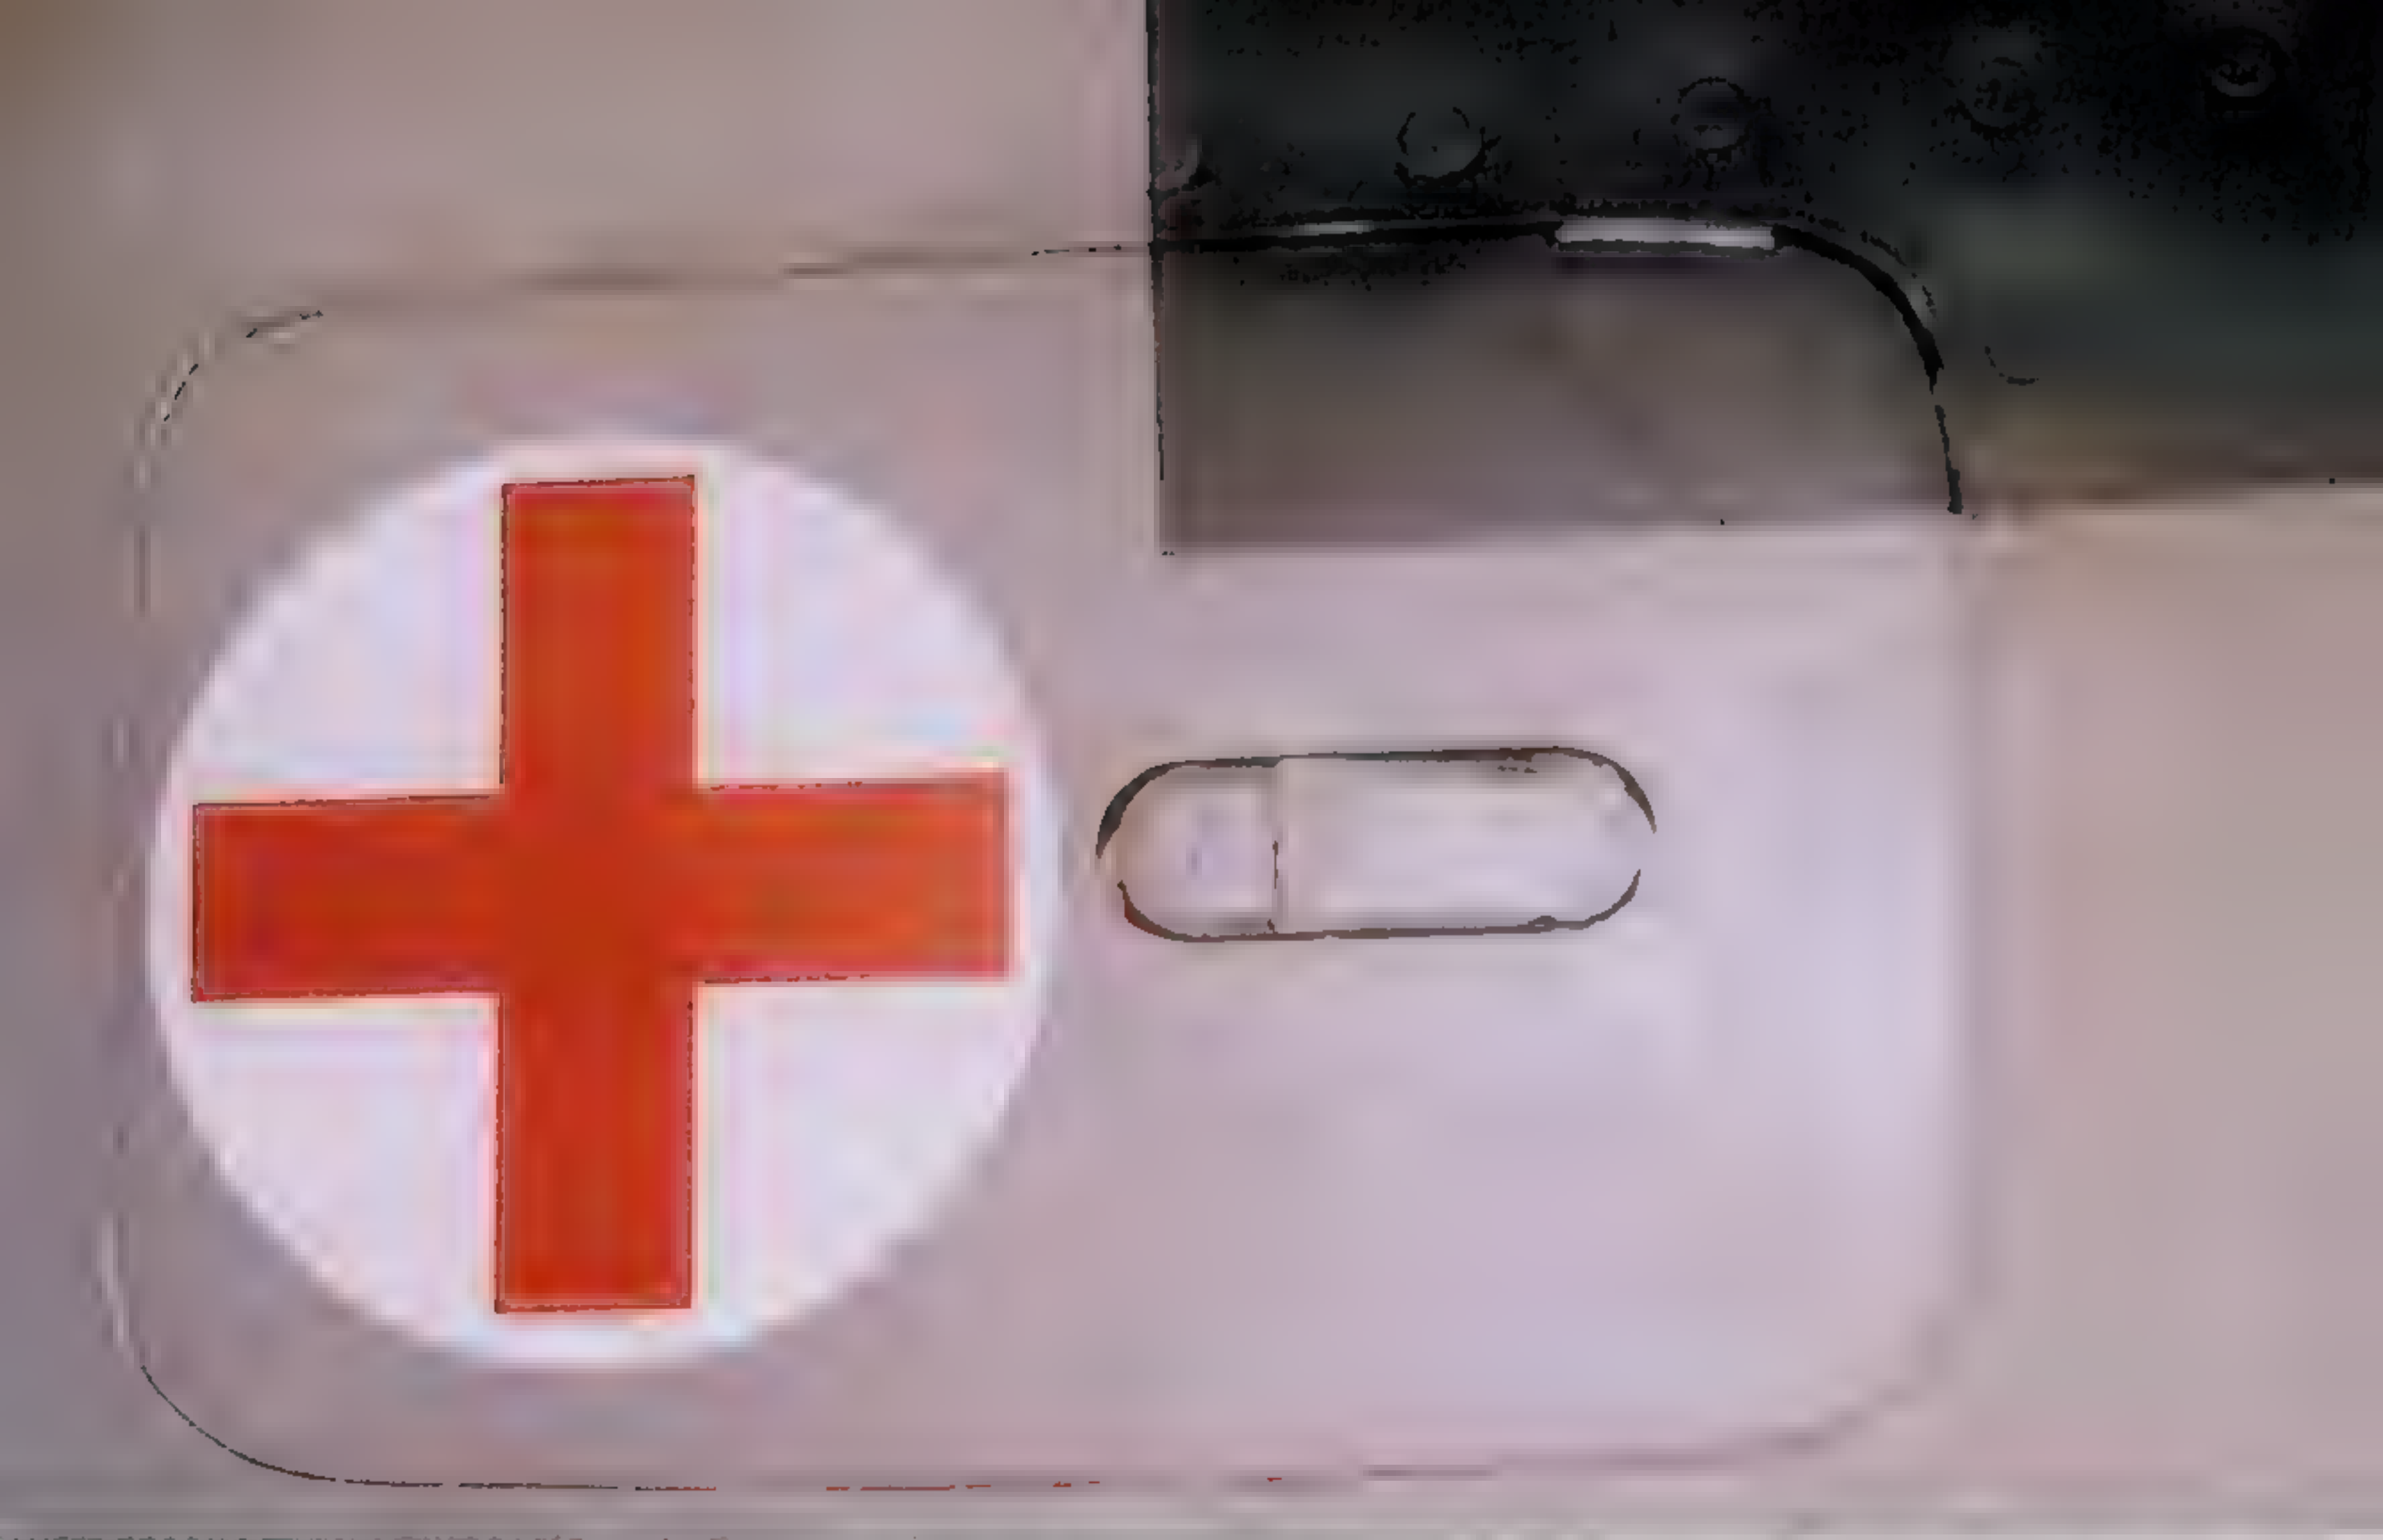
The pilot's first aid kit access panel is installed on the aft starboard fuselage of the Fw 190F-8 and is identical to such panels on other Fw 190 variants, although the location moved on the A-7 and later models. Once the flush-fitting latch is opened, this panel can be completely removed from the fuselage to obtain access to the first aid kit. (Ryle)

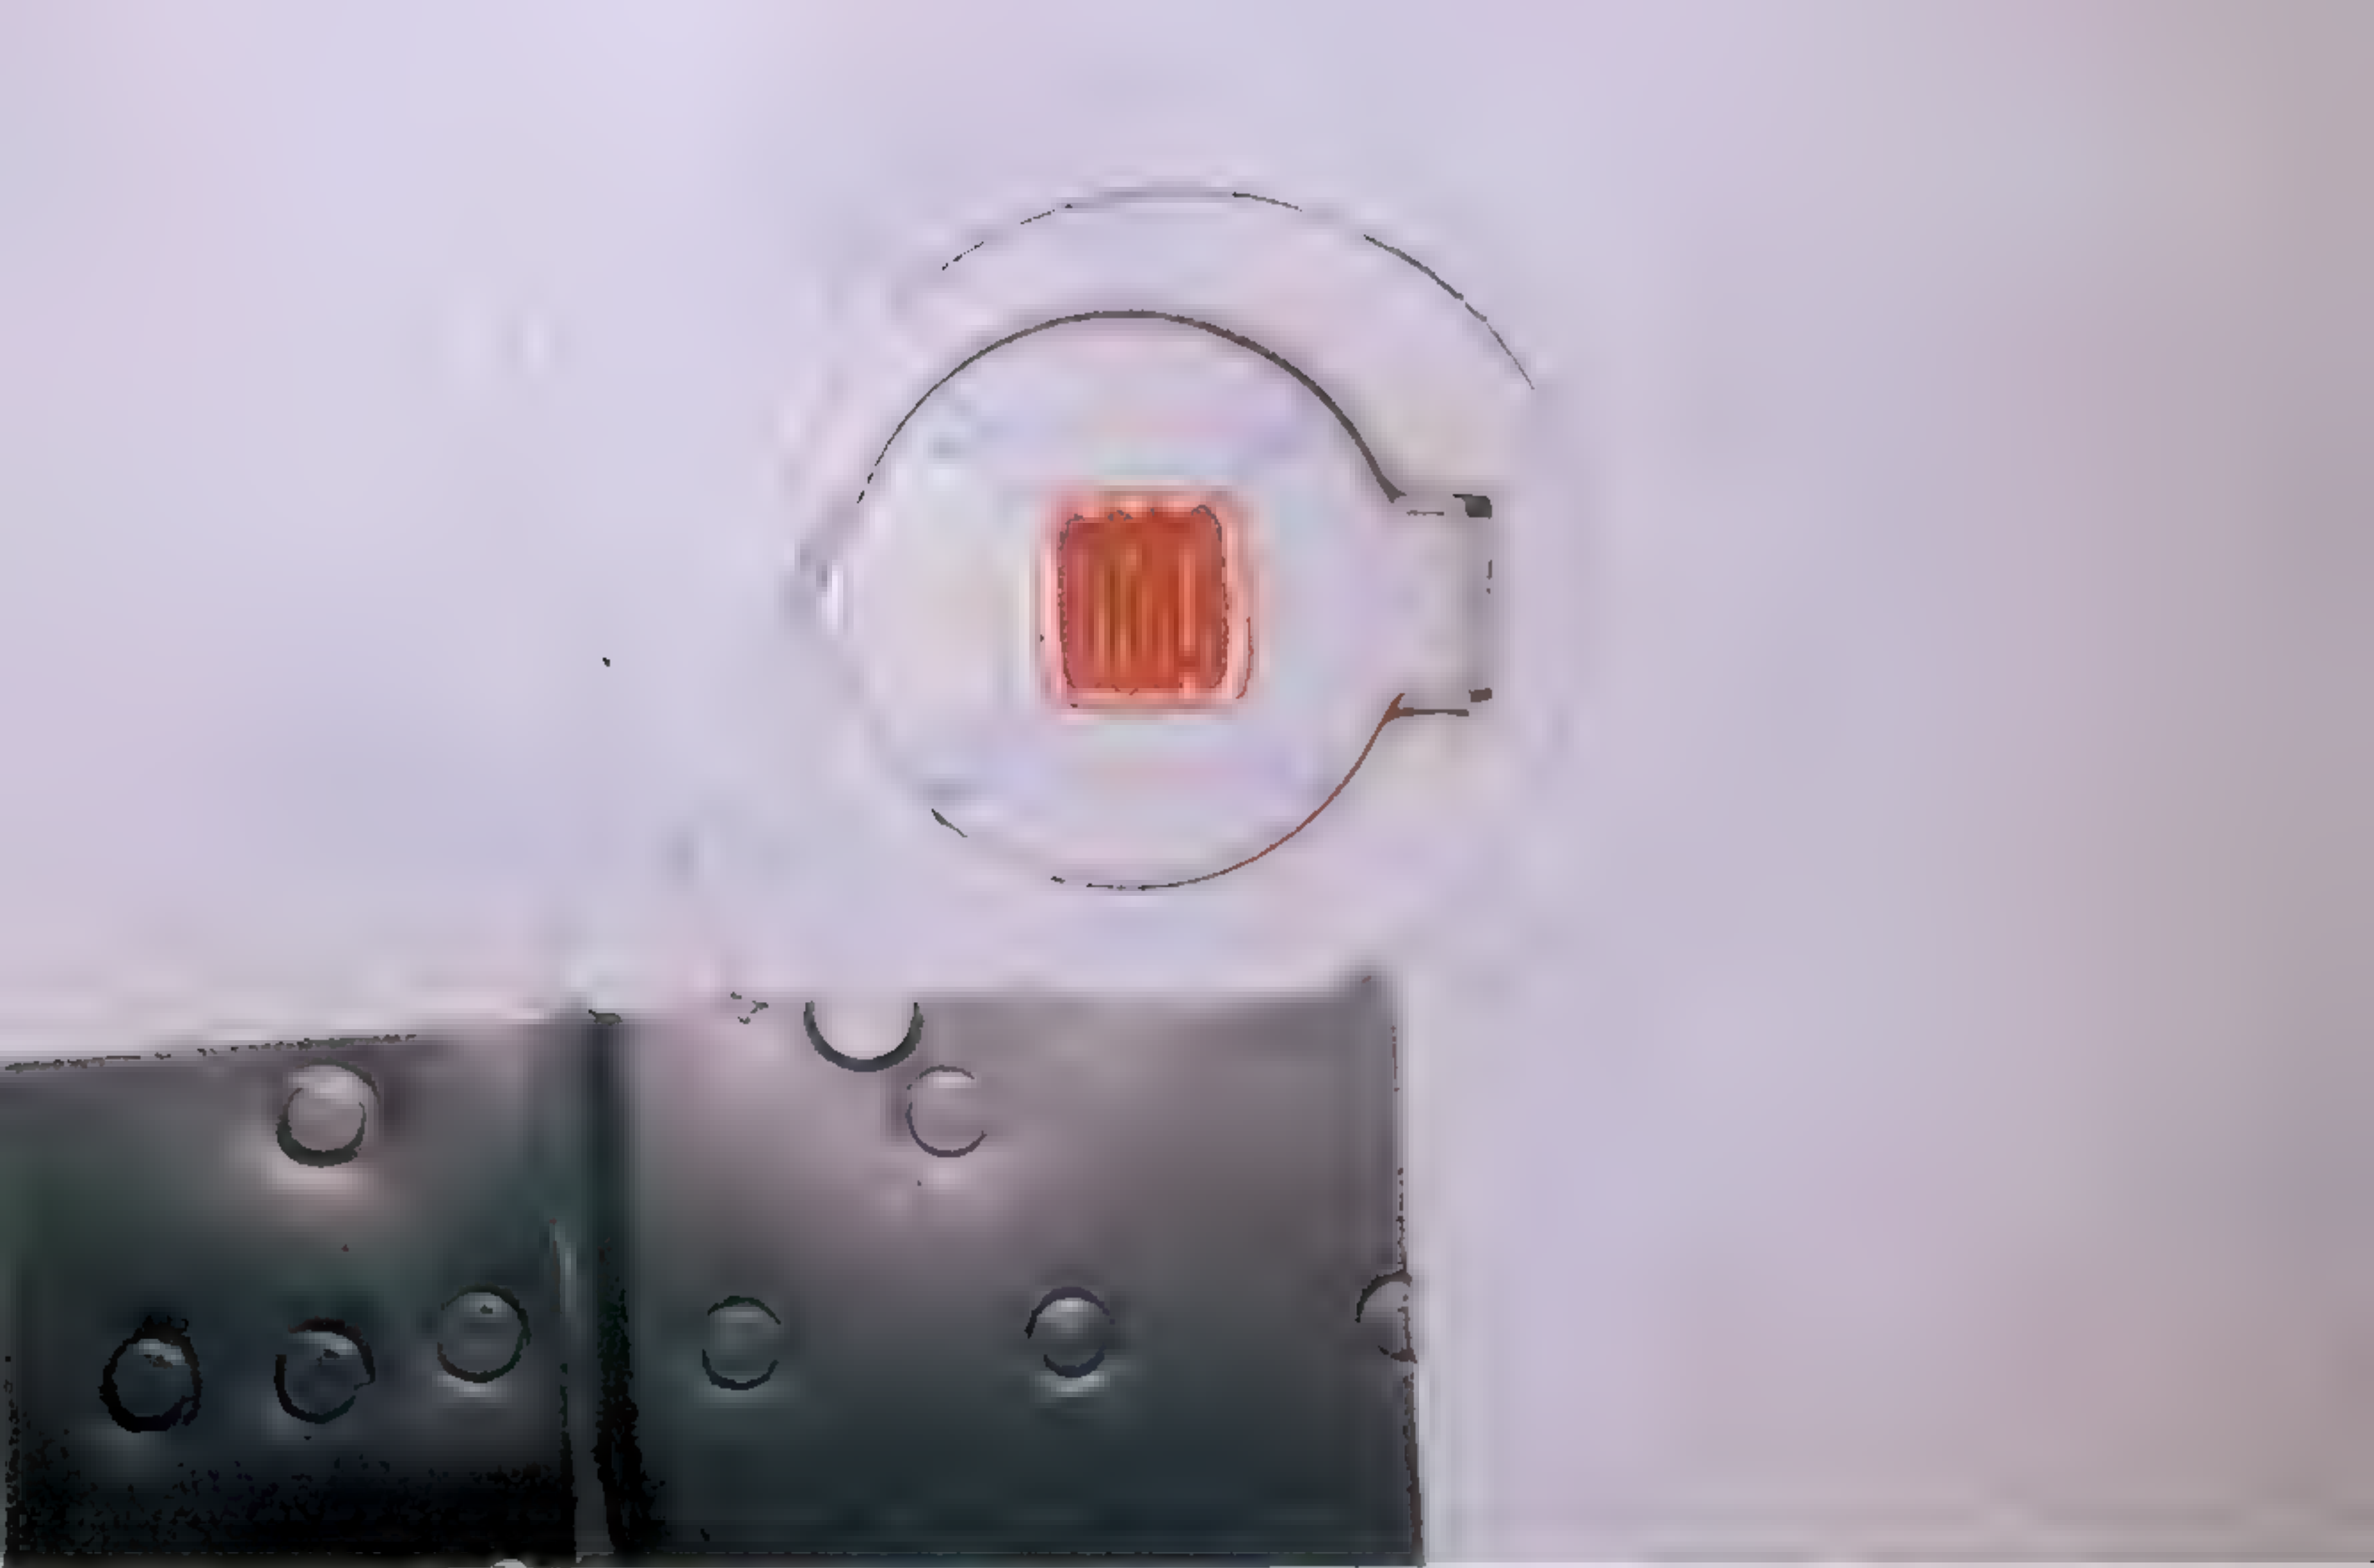
The 24-volt external power connection on the starboard aft fuselage is covered with a small flush-fitting hatch. The opening mechanism is painted red, although the entire hatch may be painted this color on some Fw 190s. The outside of the black German *Balkankreuz* (Balkan Cross) insignia is just below the power connection hatch. (Ryle)

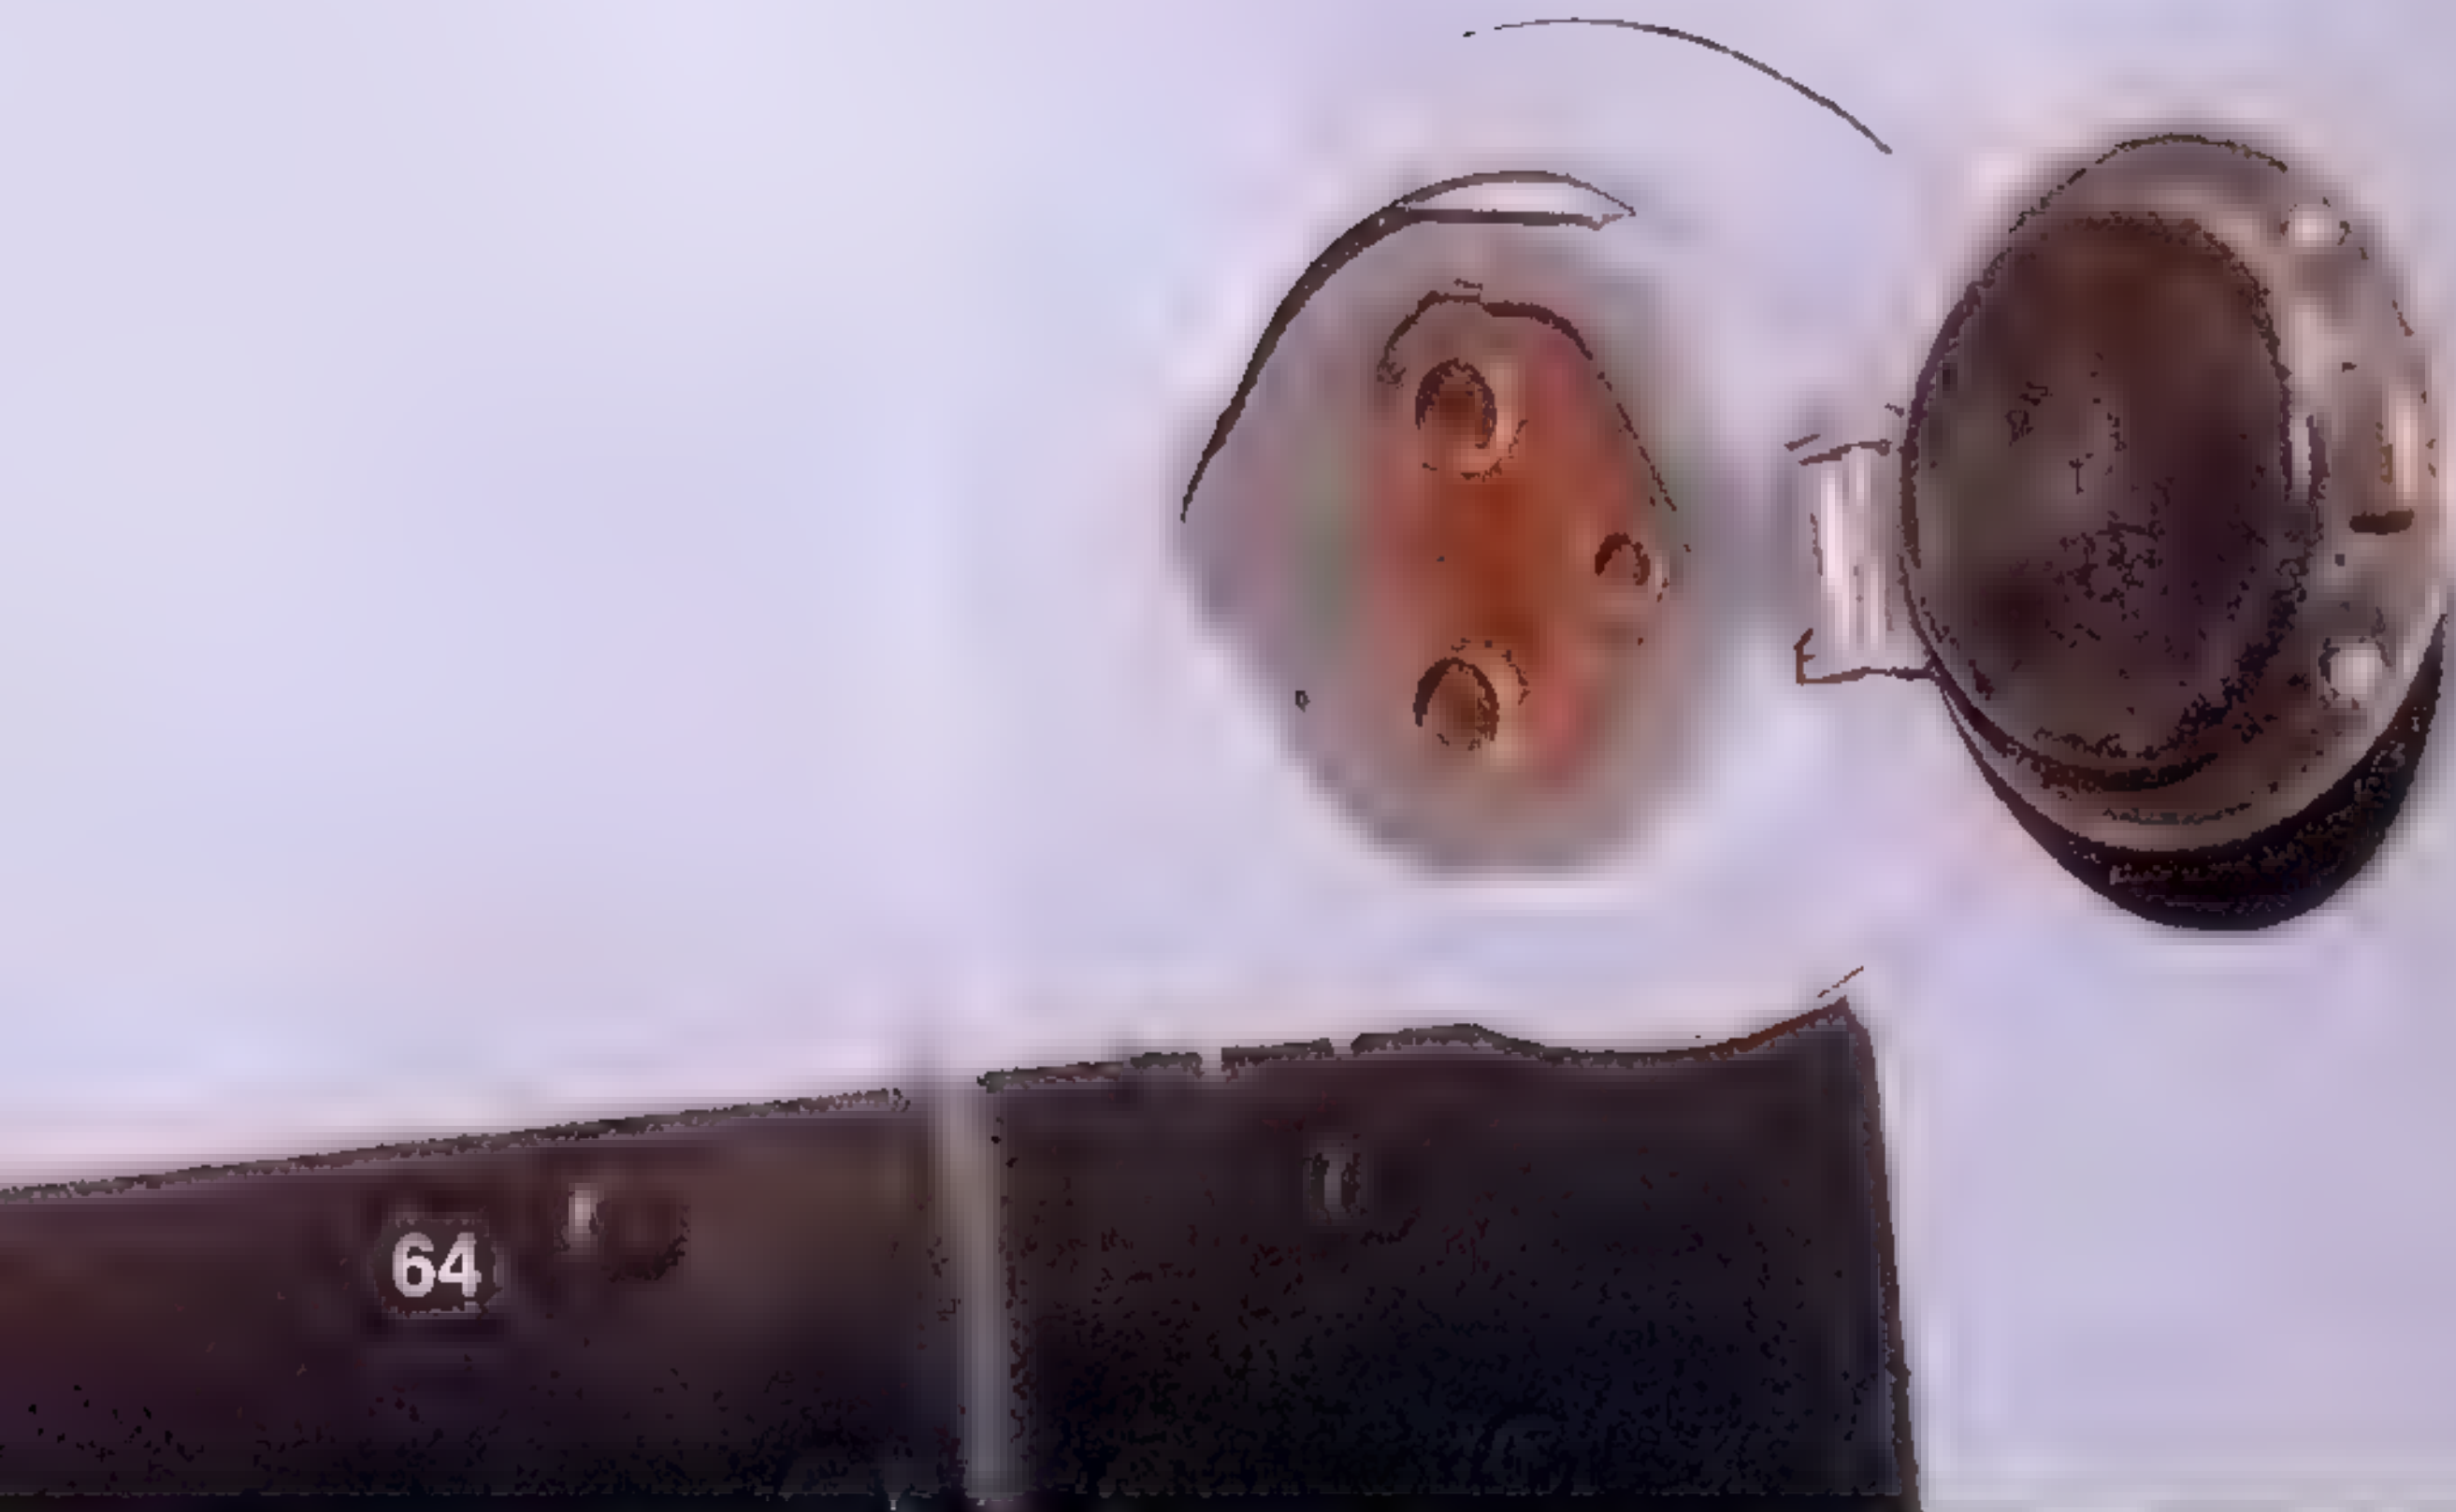
The opened external power connection hatch reveals the socket for the three-pronged external power plug. When the Fw 190F-8 was on the ground, 24V of external power was provided for charging the aircraft's battery – which provided electrical power in flight – and powering internal electrical systems for ground maintenance. (Ryle)

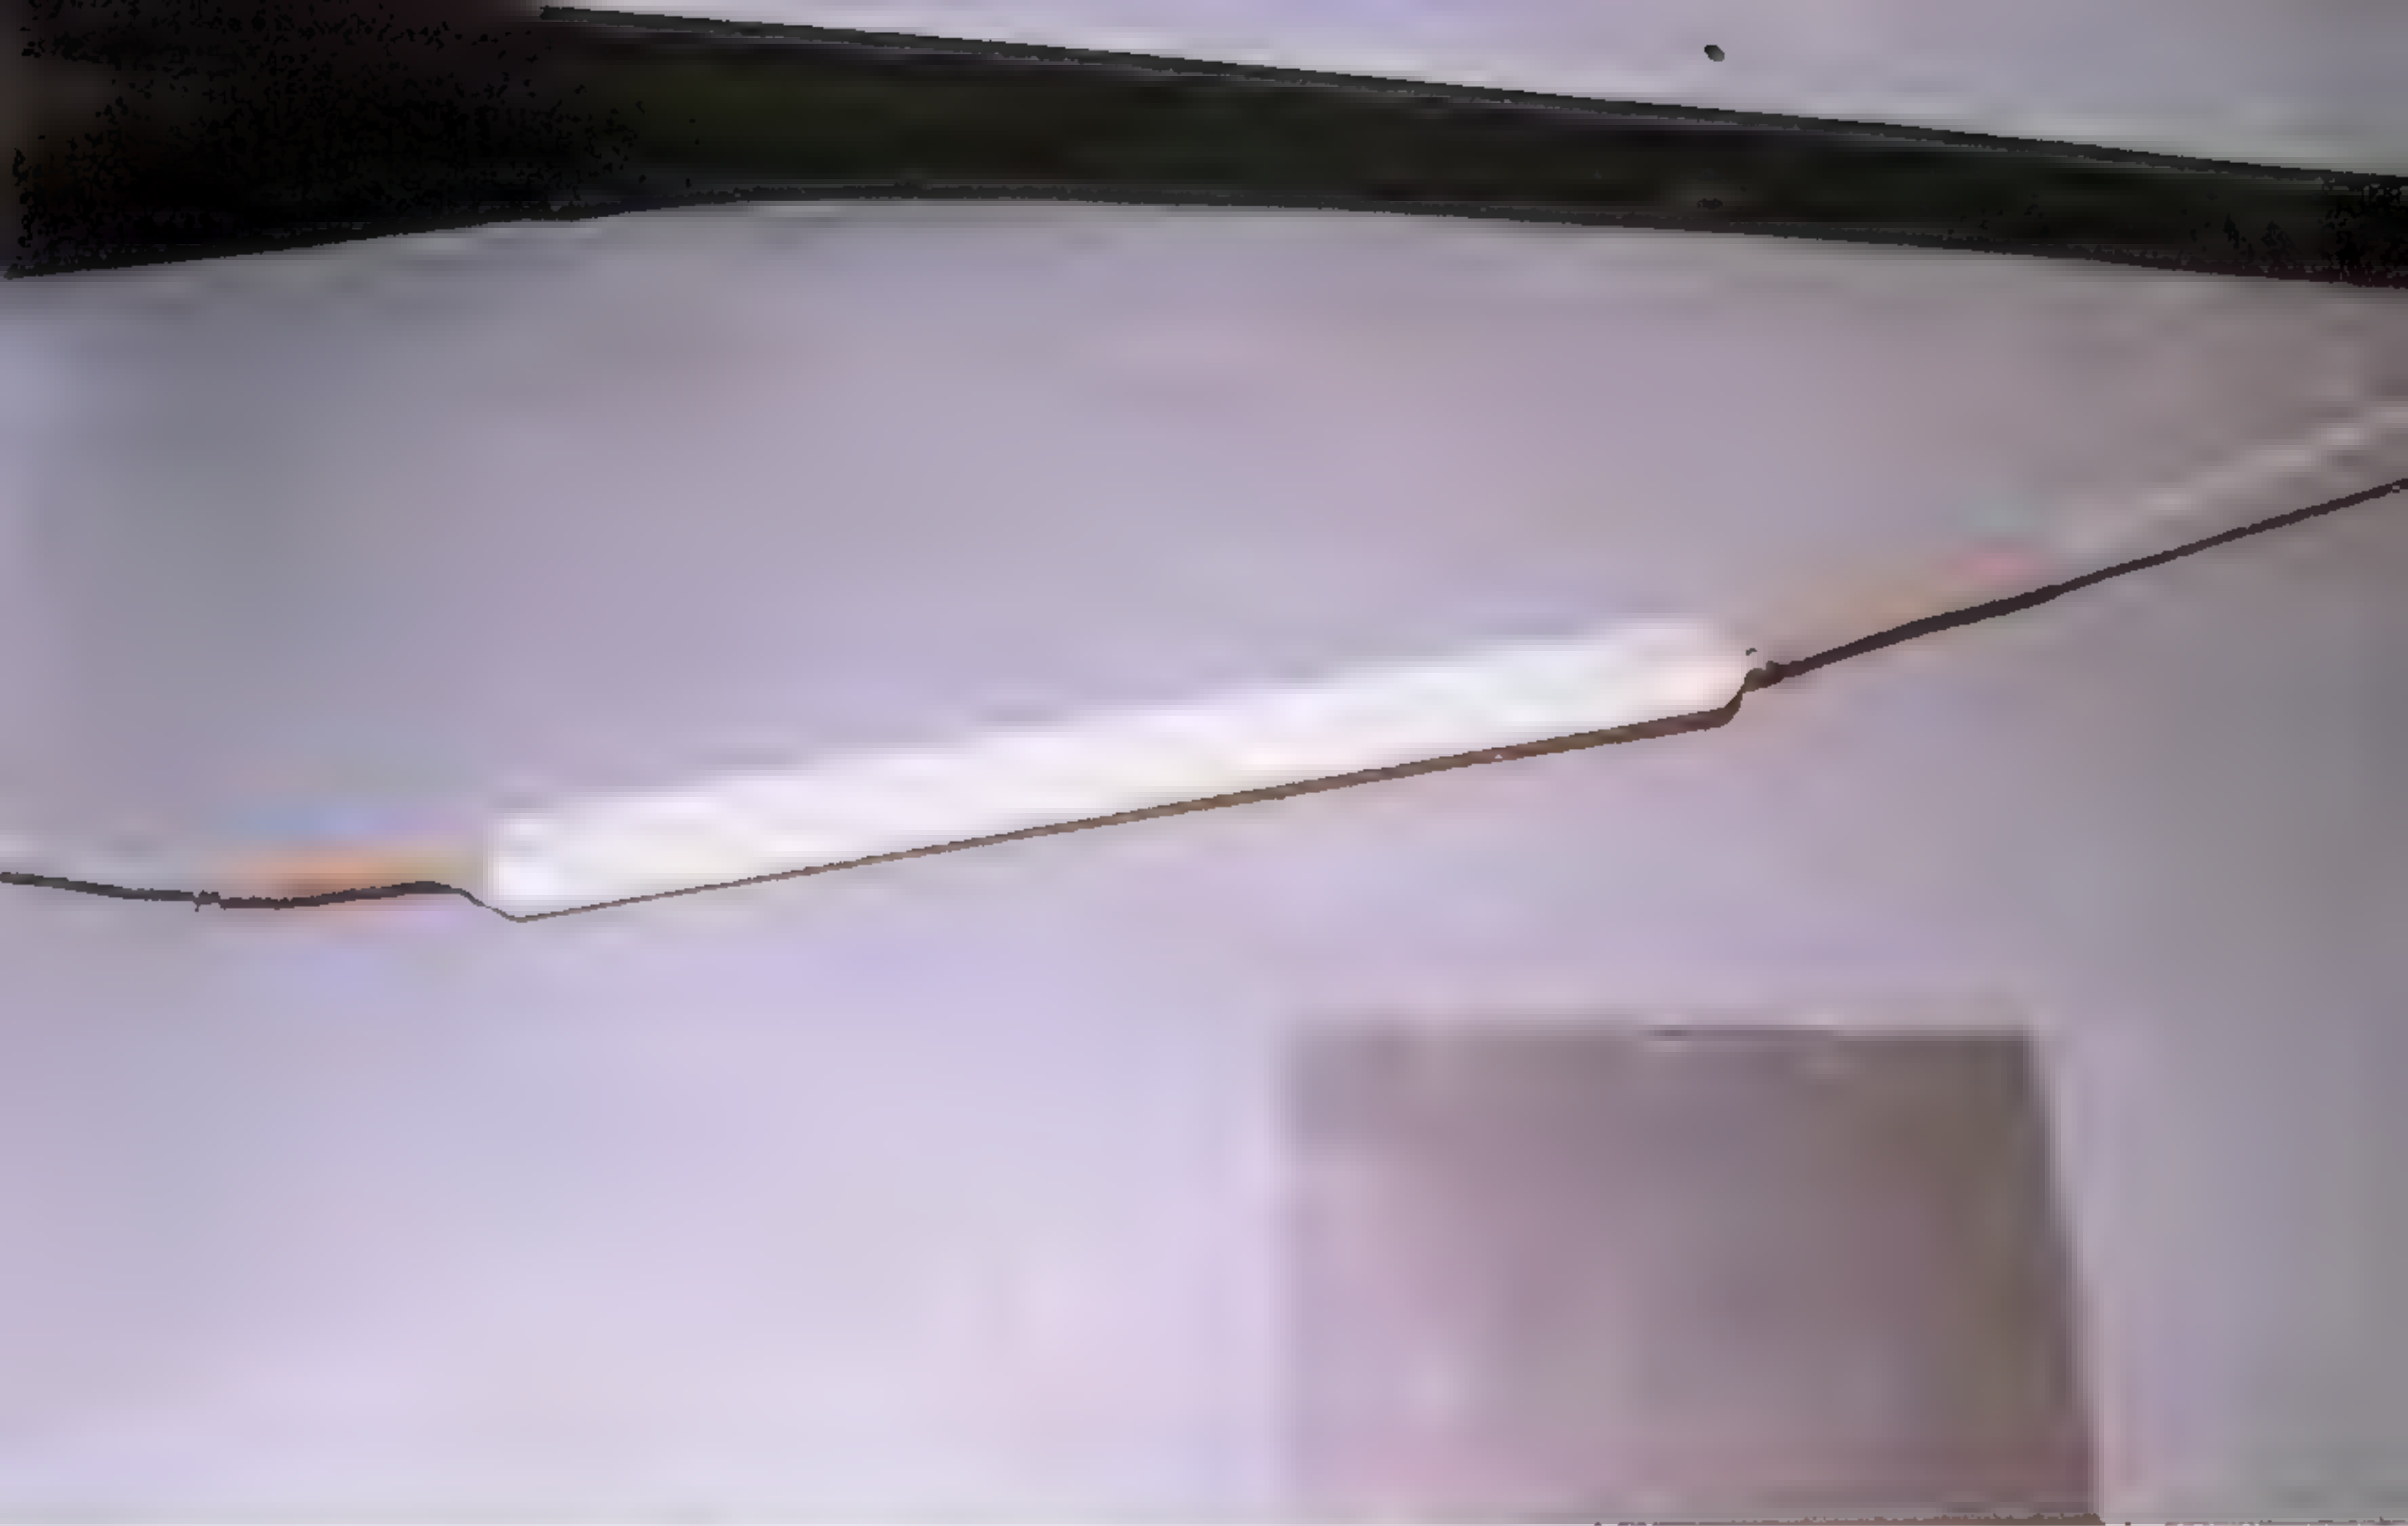
One of the two ceramic insulators on the Fw 190F-8's main antenna wire rests against the fuselage near the open canopy. This insulator prevented radio interference from the grounding of the antenna wire to the aircraft. The antenna wire on Fw 190s fitted with 'blown' canopies falls to the aircraft's spine when the canopy is open. (Ryle)

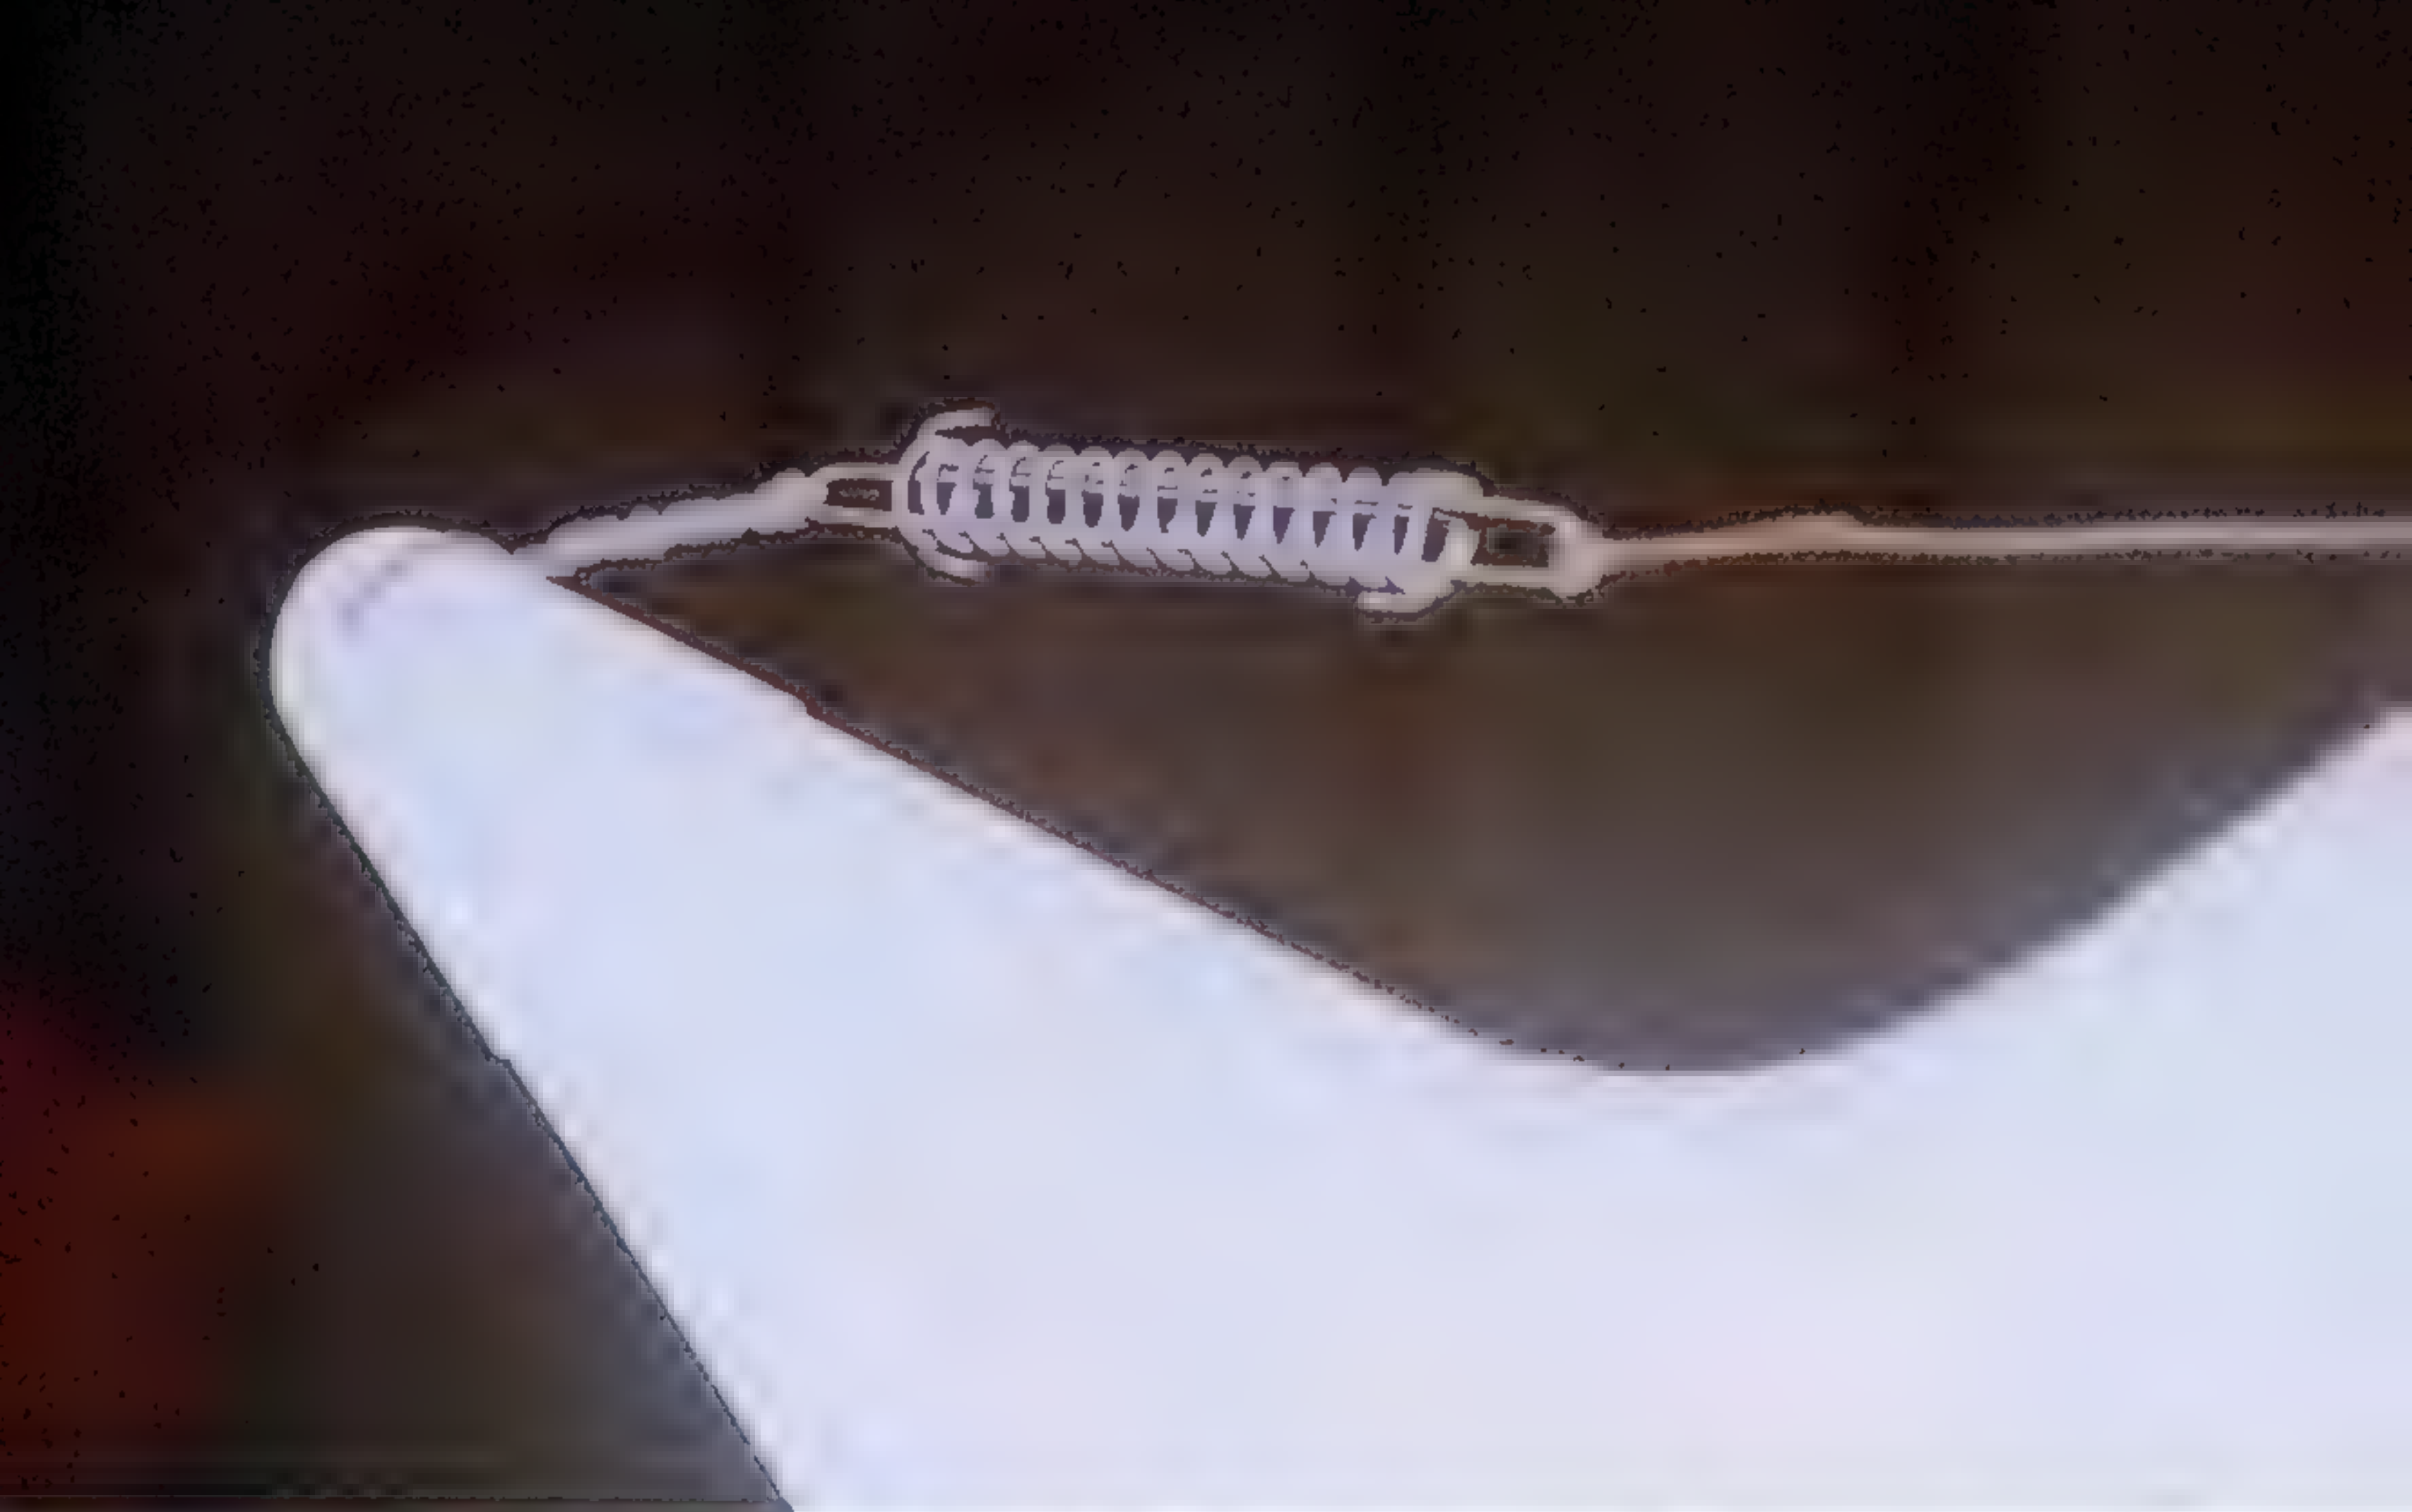
The main antenna wire connects with the Fw 190F-8's vertical stabilizer through a tensioning spring. This spring maintained proper wire tension on aircraft equipped with both 'flat' and 'blown' canopies. The vertical antenna mast introduced on the Fw 190A-4 replaced the shorter fairing used on earlier Fw 190s. (Ryle)

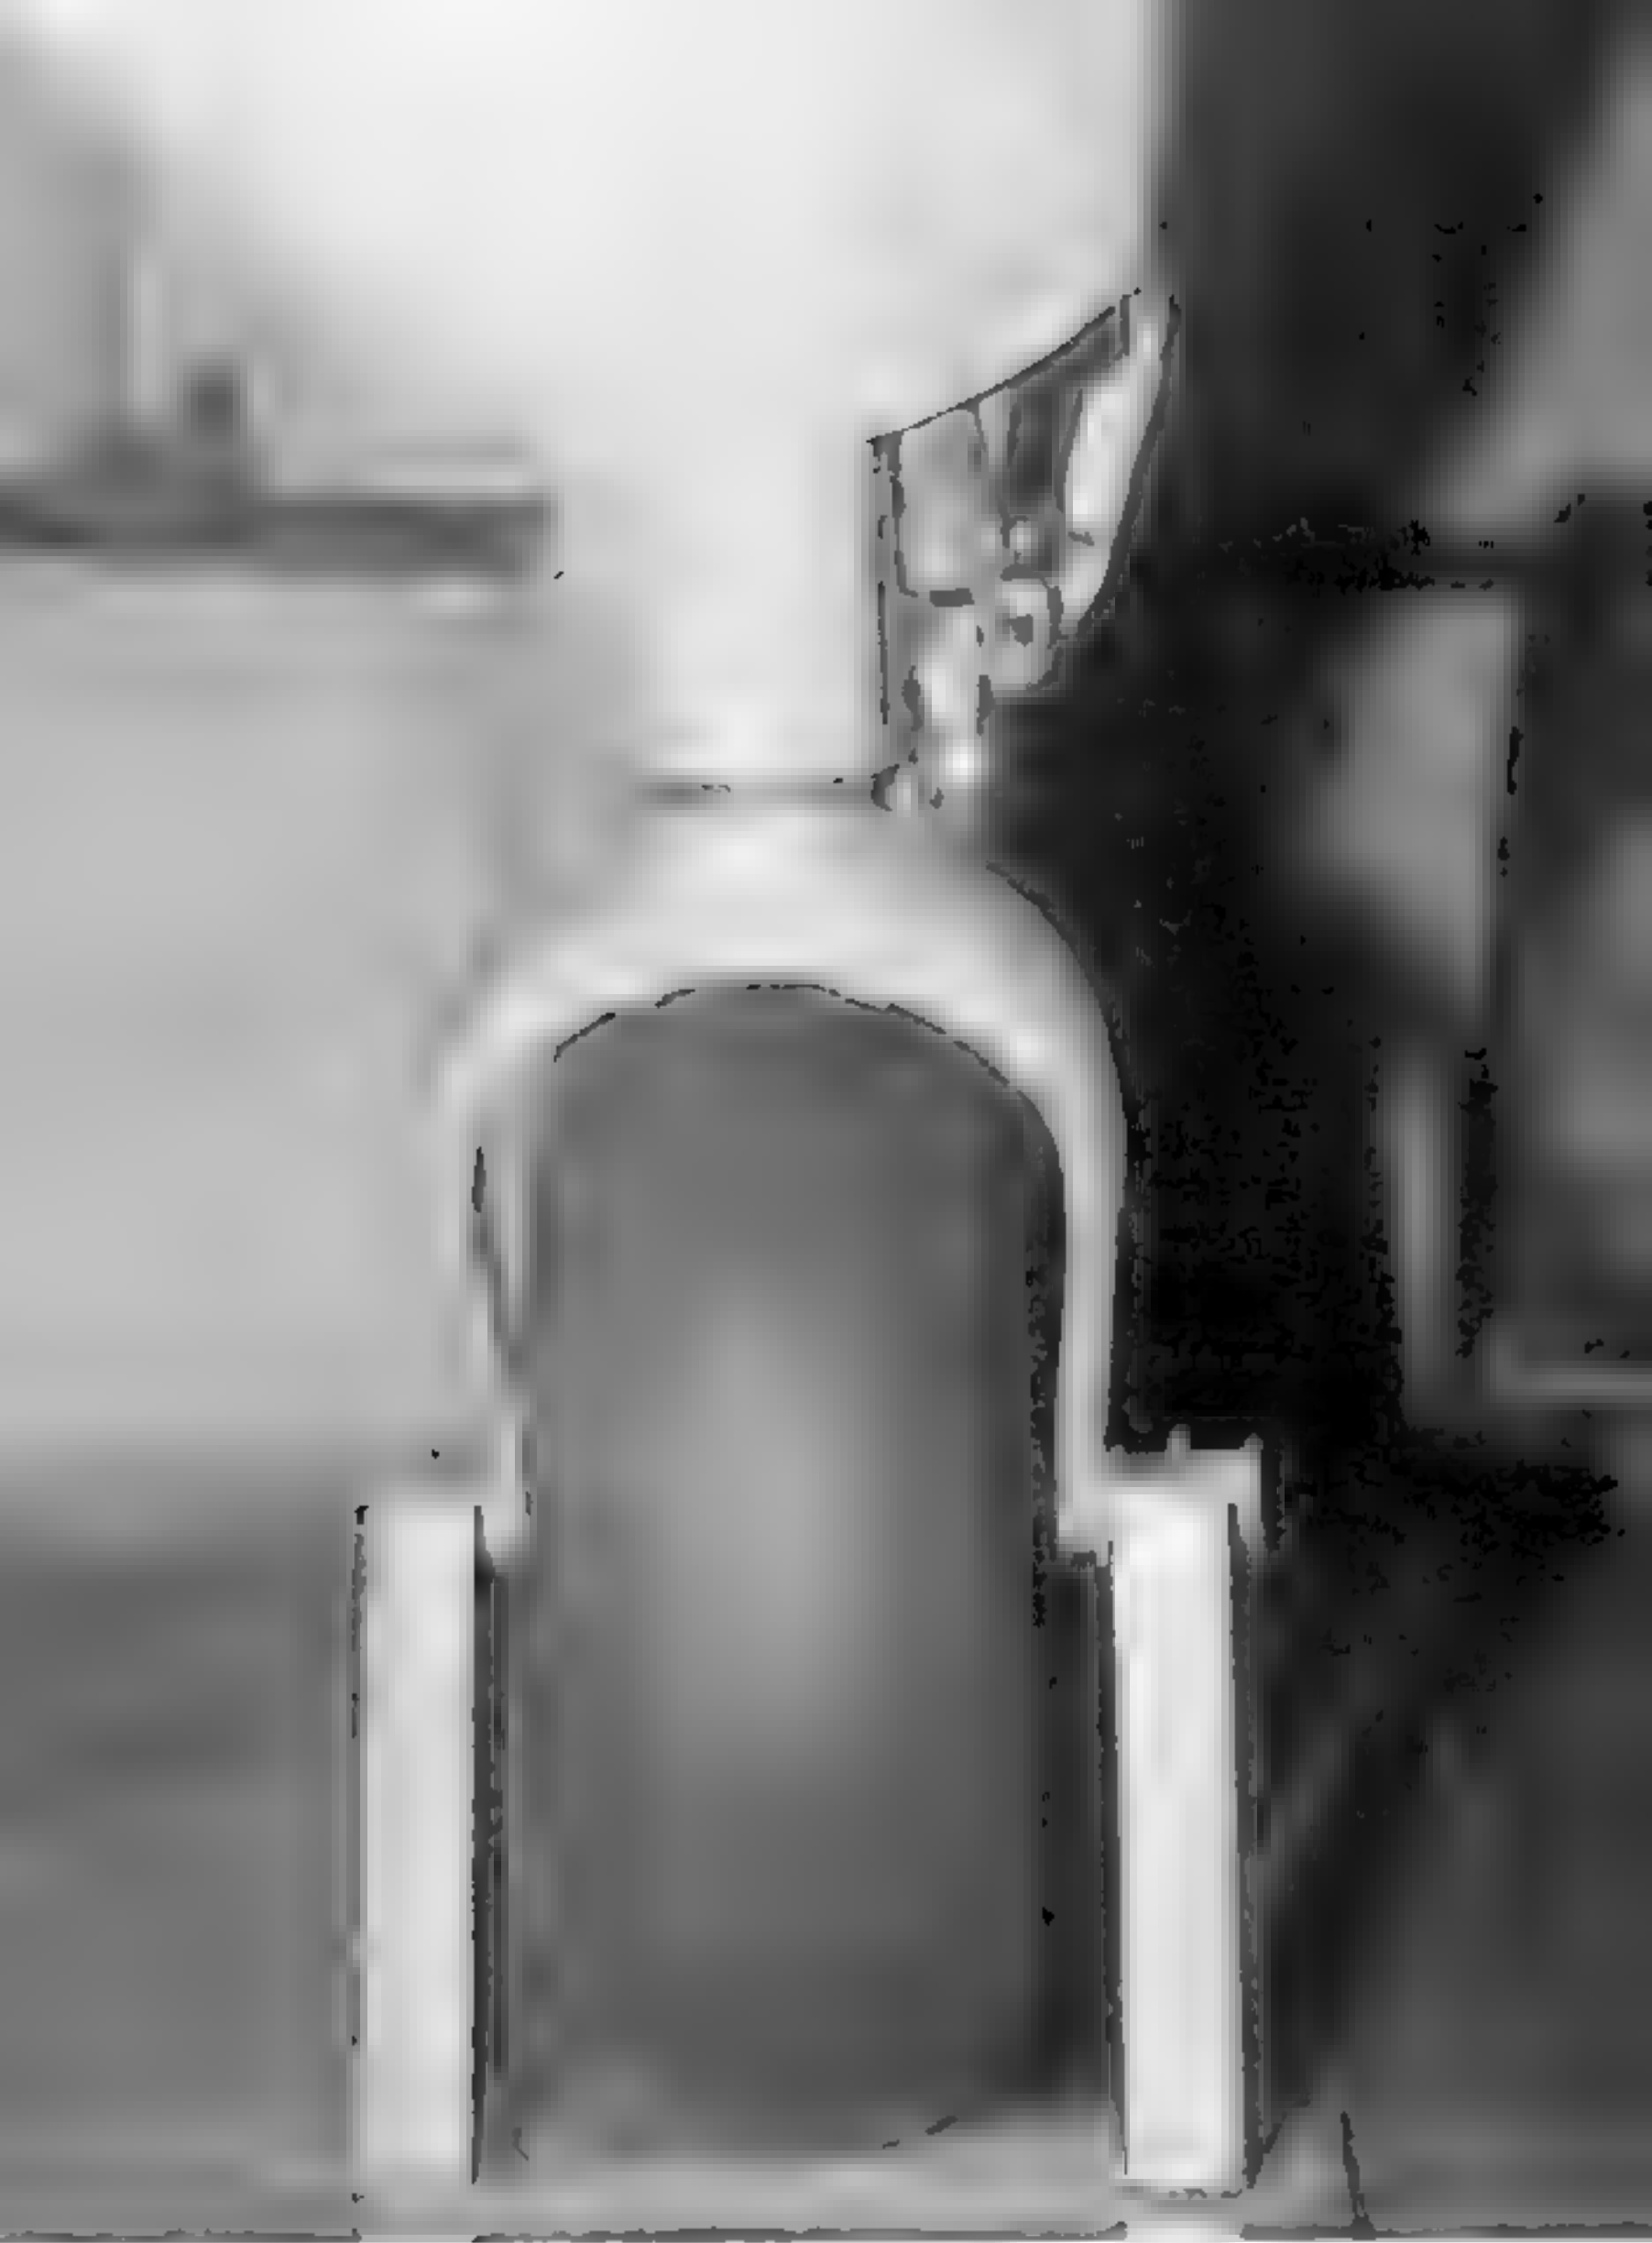
The Fw 190F-8 employed a welded steel fork tail wheel housing around the tire. The fork is bowed slightly inward. The tail wheel hub extensions are for a forked tail wheel bar, used by ground personnel to control the aircraft's direction when towed. These extensions rest in a cradle used to raise this preserved Fw 190F-8 slightly off the ground to eliminate pressure on the tires. (Ryle)
